Manhole Inspection Summary

Manhole # S19E__029MH

Location Address: **2033 SARATOGUE-PENROSE**

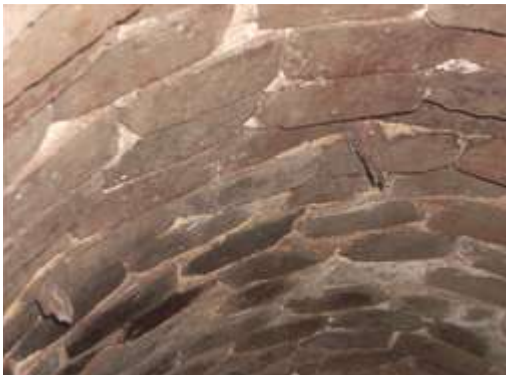
Defect 3

Infiltration: ☐ None ☒ **Joint** ☐ Cracks ☐ Mortar ☐ Roots ☒ **Wall**

Steps Count: **0** Missing: **1** ☐ Corroded

MISSING STEP AND CORBEL WALL INFILTRATION

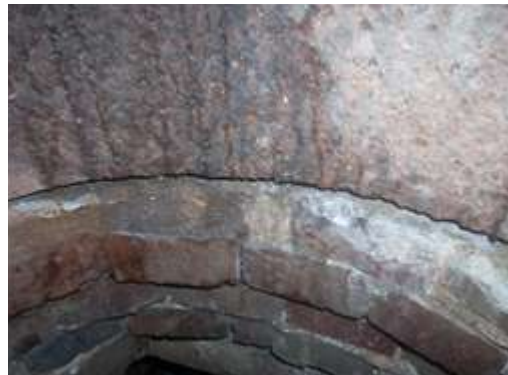
Defect 2

Condition: ☐ Sound ☐ Cracked ☐ Root Intrusion ☒ **Loose Brick** ☒ **Deteriorated**

DETERIORATED CORBEL AND JOINT INFILTRATION

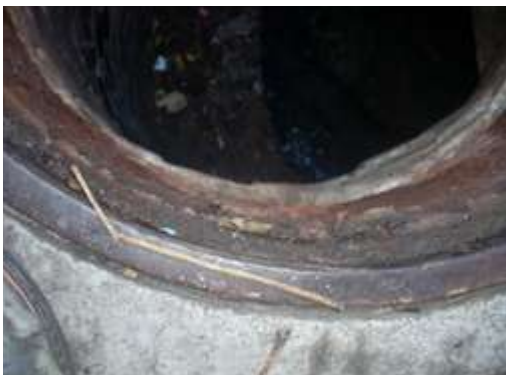
Defect 1

Frame Offset: **1** (in.) Condition: ☒ Sound ☐ Cracked ☐ Leaks

FRAME OFFSET

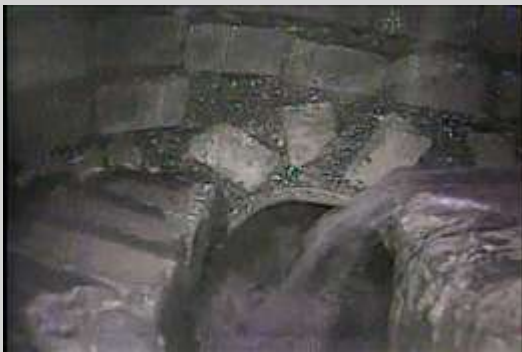
12 O'Clock Outflow

Pipe Height: **7.2** (in.) Rod and Bar (Angled)
Pipe Material: **Clay** ☐ Pipe Lined
Invert Depth: **8.52** (ft.) Flow Characteristics: **Fast**
Deposits: ☒ None ☐ Mud ☐ Sludge ☐ Debris ☐ Grease
Silt Depth: (in.) Deposits Extent:
Infiltration: **None** Pipe Seal Cond: **Sound**

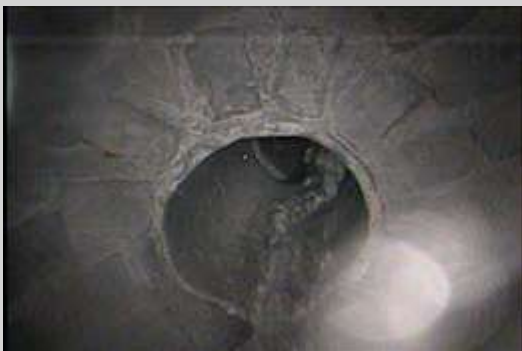
6 O'Clock Inflow

MISSING STEP AND CORBEL WALL
INFILTRATION

Pipe Height: **7.2** (in.) Rod and Bar (Angled)
Pipe Material: **Clay** ☐ Pipe Lined
Invert Depth: **5.17** (ft.) Flow Characteristics: **Fast**
Deposits: ☒ None ☐ Mud ☐ Sludge ☐ Debris ☐ Grease
Silt Depth: (in.) Deposits Extent:
Infiltration: **None** Pipe Seal Cond: **Broken**

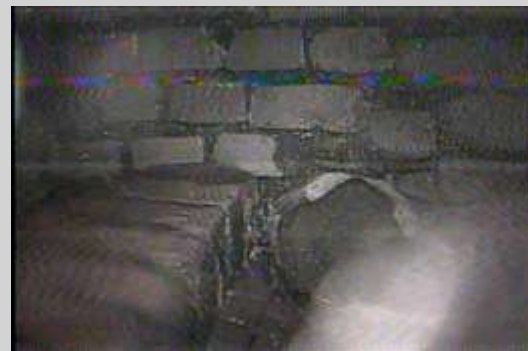
Drop In @ 6 O'Clock

MISSING STEP AND CORBEL WALL
INFILTRATION

Drop: **Outside** Rod and Bar
Angled: **Yes** Reading: **7.32** (ft.)
Inv Depth: **8.32** (ft.)
Drop Condition: **Clogged**
